Service manual
VRV IV+ Heat Recovery

VRV IV⁺

REYQ8U7Y1B
REYQ10U7Y1B
REYQ12U7Y1B
REYQ14U7Y1B
REYQ16U7Y1B
REYQ18U7Y1B
REYQ20U7Y1B

REMQ5U7Y1B

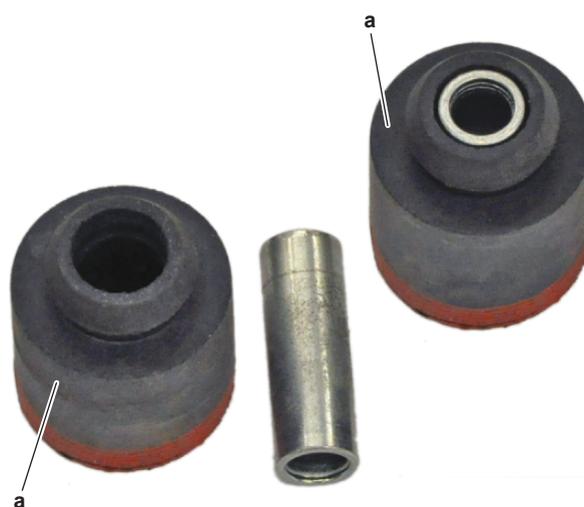
- 2 Check the compressor dampers and piping for any damage.

1 Damper

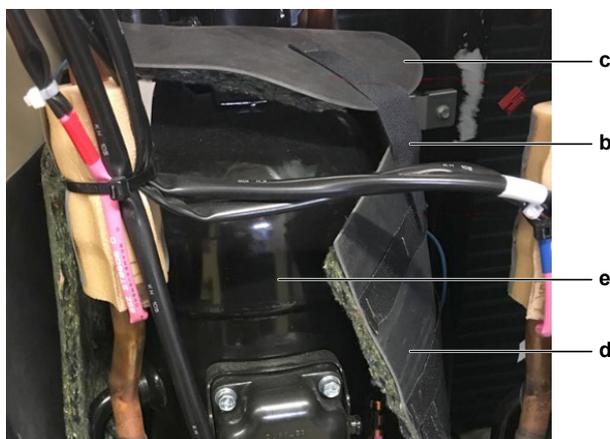
To install the compressor insulation

- b** Strip
- c** Top jacket
- d** Body jacket
- e** Compressor

- 1** Install the body jacket (d) on the compressor (e).
- 2** Install the top jacket (c).
- 3** Attach the strip (b) to the top jacket (c).

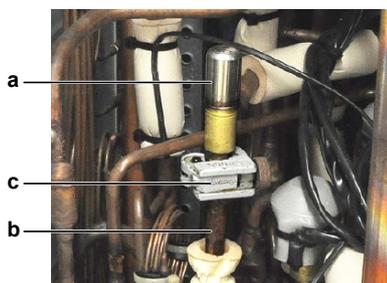
- 1 Remove the expansion valve motor, see ["Repair procedures"](#) [▶ 247].
- 2 Cut the expansion valve pipes using a pipe cutter.

a Expansion valve body
b Expansion valve pipe
c Pipe cutter

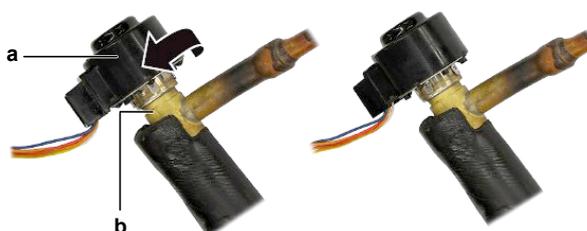
The correct alignment of the expansion valve motor is ensured by dimples.

- a Expansion valve motor
- b Pipe

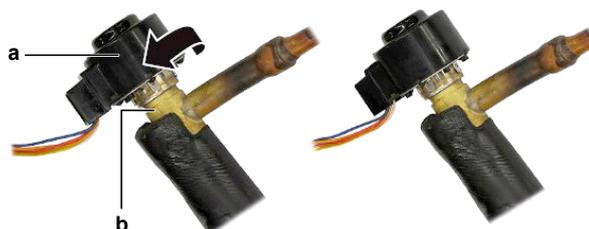
Turn the expansion valve motor 1/8 turn clockwise to lock it on the expansion valve body.

- a** Expansion valve motor
- b** Pipe

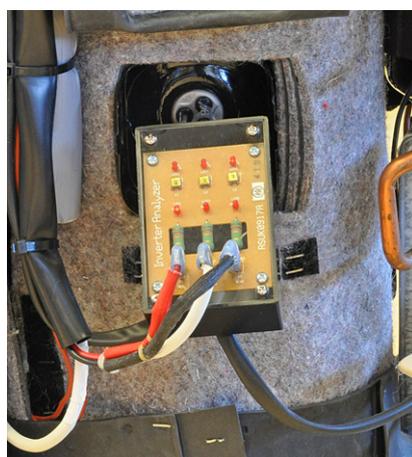
- 4 Connect the Faston connectors to the Inverter Analyzer (SPP number 1368521).

a Inverter checker
b Faston terminal U
c Faston terminal V
d Faston terminal W

e 2 LEDs for phase U
f 2 LEDs for phase V
g 2 LEDs for phase W

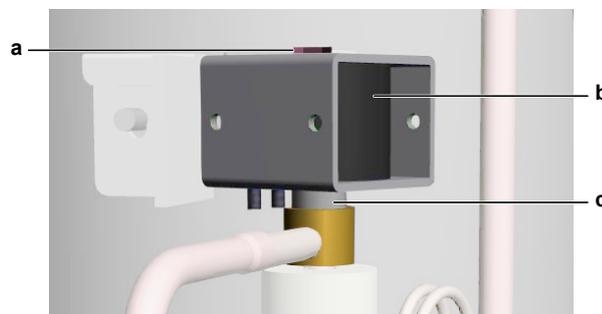
- 1 Remove the screw and remove the oil return valve coil from the oil return valve body.

a Screw
b Valve coil
c Valve body

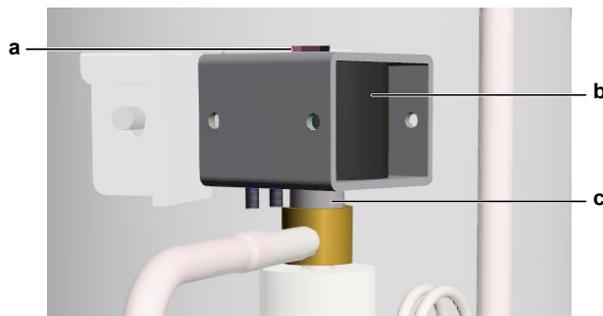
To install the oil return valve coil

- 1 Install the oil return valve coil on the oil return valve body.

a Screw
b Valve coil
c Valve body

- 2 Install and tighten the screw to fix the oil return valve coil.
- 3 Route the oil return valve coil harness towards the appropriate PCB.
- 4 Connect the oil return valve coil connector to the PCB.

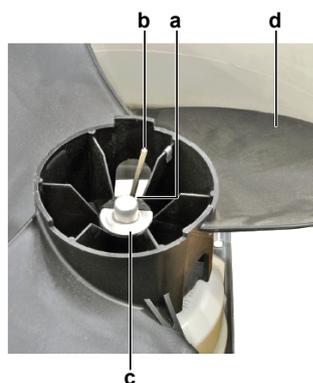
- 2 Install the axle cover.
- 3 Install and tighten the screw using an Allen key to fix the propeller fan blade assembly.

- a Screw
- b Allen key
- c Axle cover
- d Propeller fan blade assembly

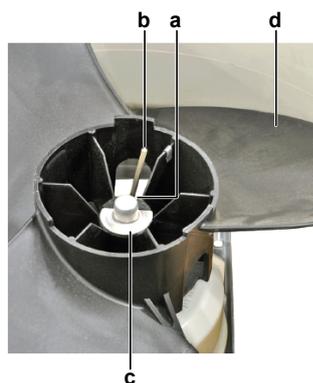
- 2 Install the axle cover.
- 3 Install and tighten the screw using an Allen key to fix the propeller fan blade assembly.

- a Screw
- b Allen key
- c Axle cover
- d Propeller fan blade assembly

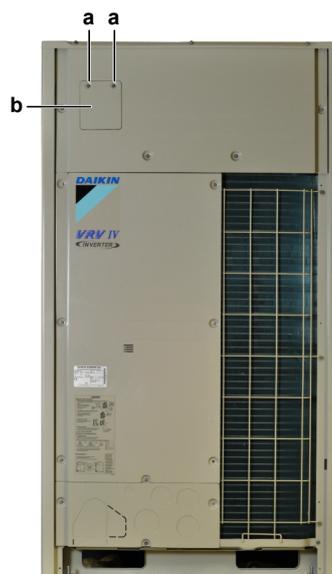
To remove the service plate

- a Screw
- b Service plate

- 2 Loosen and remove the 2 screws (a) that fix the service plate assembly.
- 3 Remove the service plate assembly (b) from the unit.

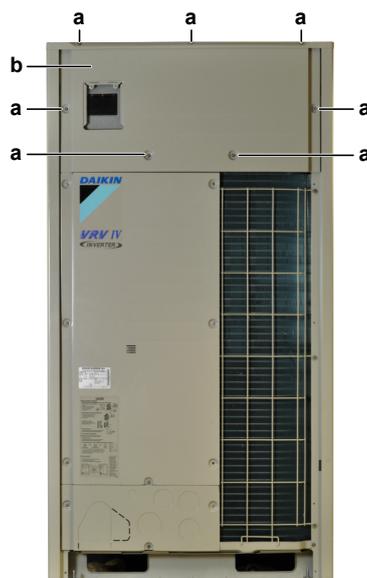
To remove the upper front plate

- a Screw
- b Upper front plate

- 4 Loosen and remove the 7 screws (a) that fix the upper front plate assembly.
- 5 Lift the upper front plate assembly (b) and remove it from the unit.

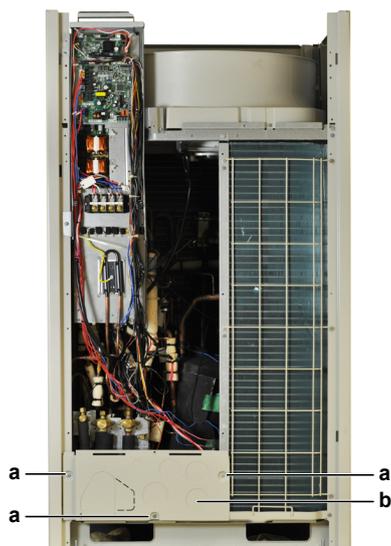
To remove the lower front plate

- a Screw
- b Lower front plate

10 Loosen and remove the 3 screws (a) that fix the lower front plate assembly.

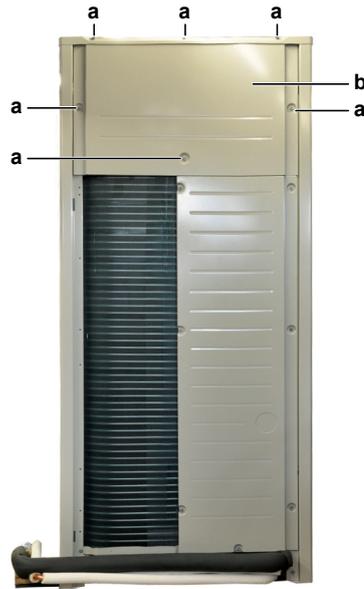
To remove the upper side plate

- a Screw
- b Upper side plate

14 Loosen and remove the 6 screws (a) that fix the upper side plate assembly.

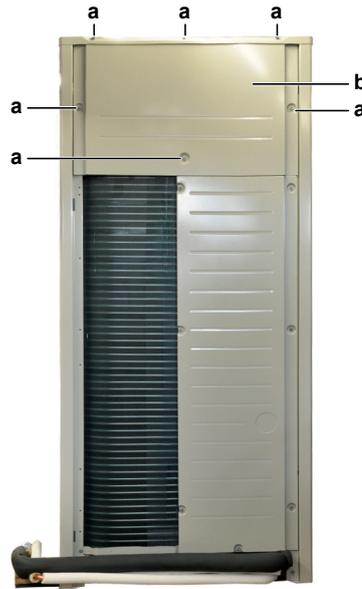
To remove the upper side plate

- a Screw
- b Upper side plate

14 Loosen and remove the 6 screws (a) that fix the upper side plate assembly.
